**COMPLICANZE: PREVENZIONE E TRATTAMENTO NELLA CHIRURGIA DELL'ANCA DALL'ARTROSCOPIA ALLA PROTESI**

## **PRIMO IMPIANTO: COMPLICANZE CERAMICA CERAMICA**

# **DESCRIZIONE DEL PROBLEMA**

**Aldo Toni**

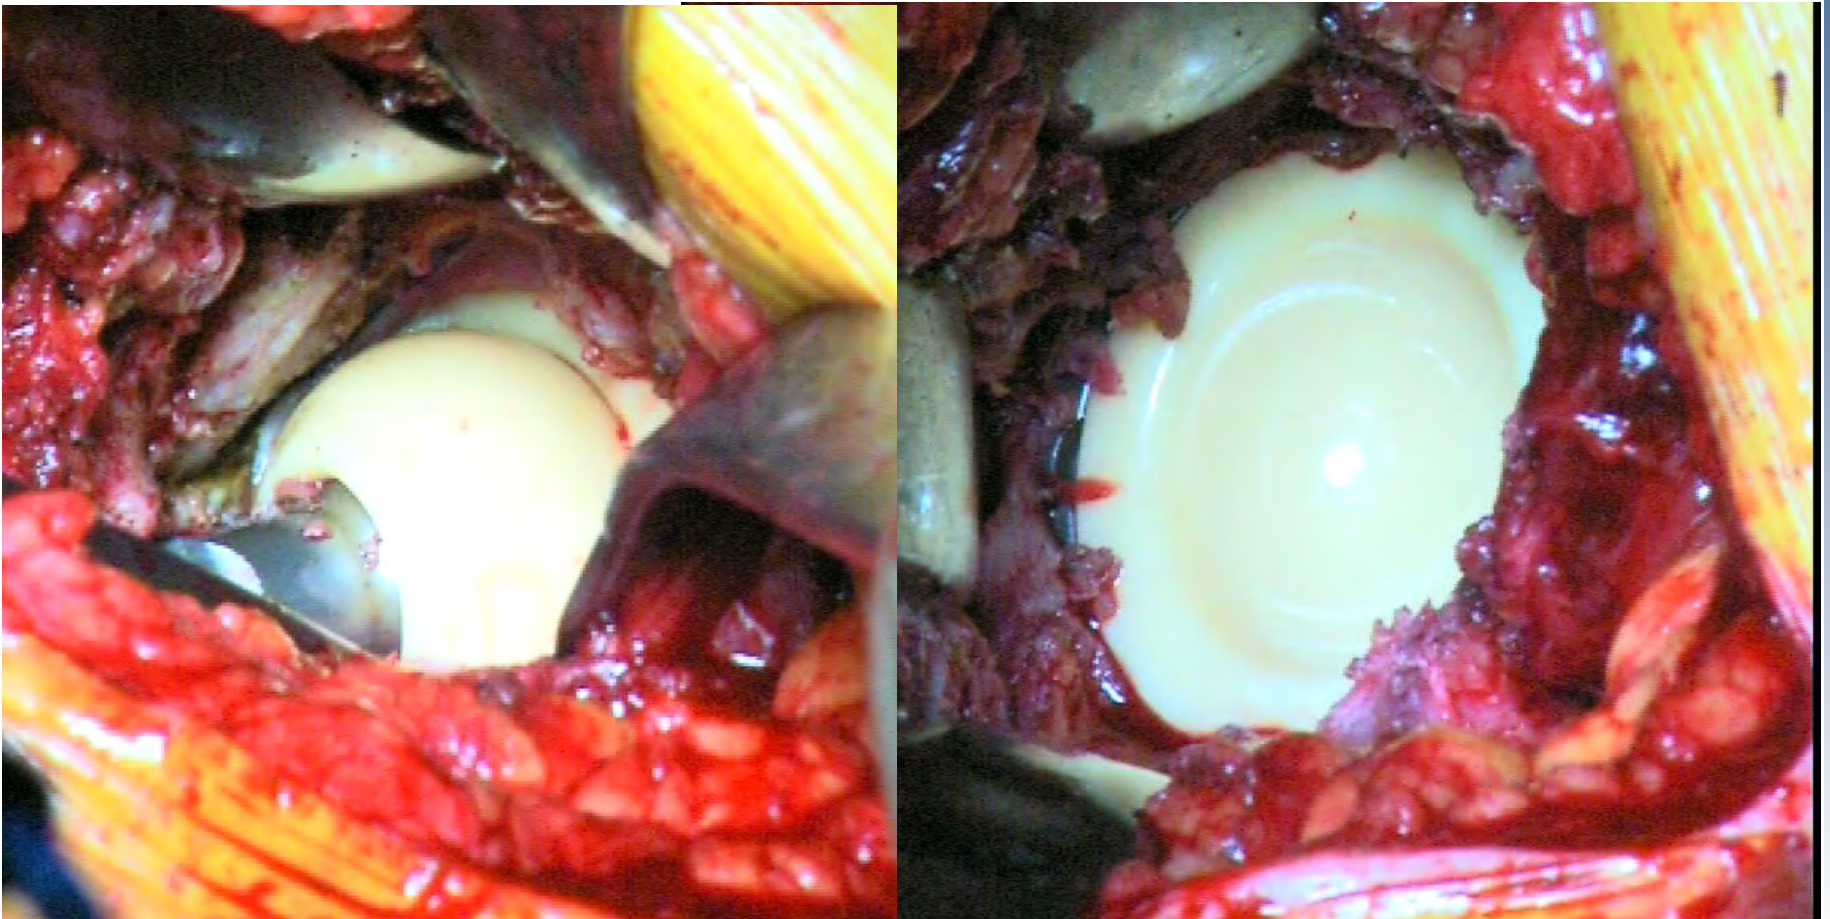
# Squeaking hip

**No danno macroscopico visibile!**

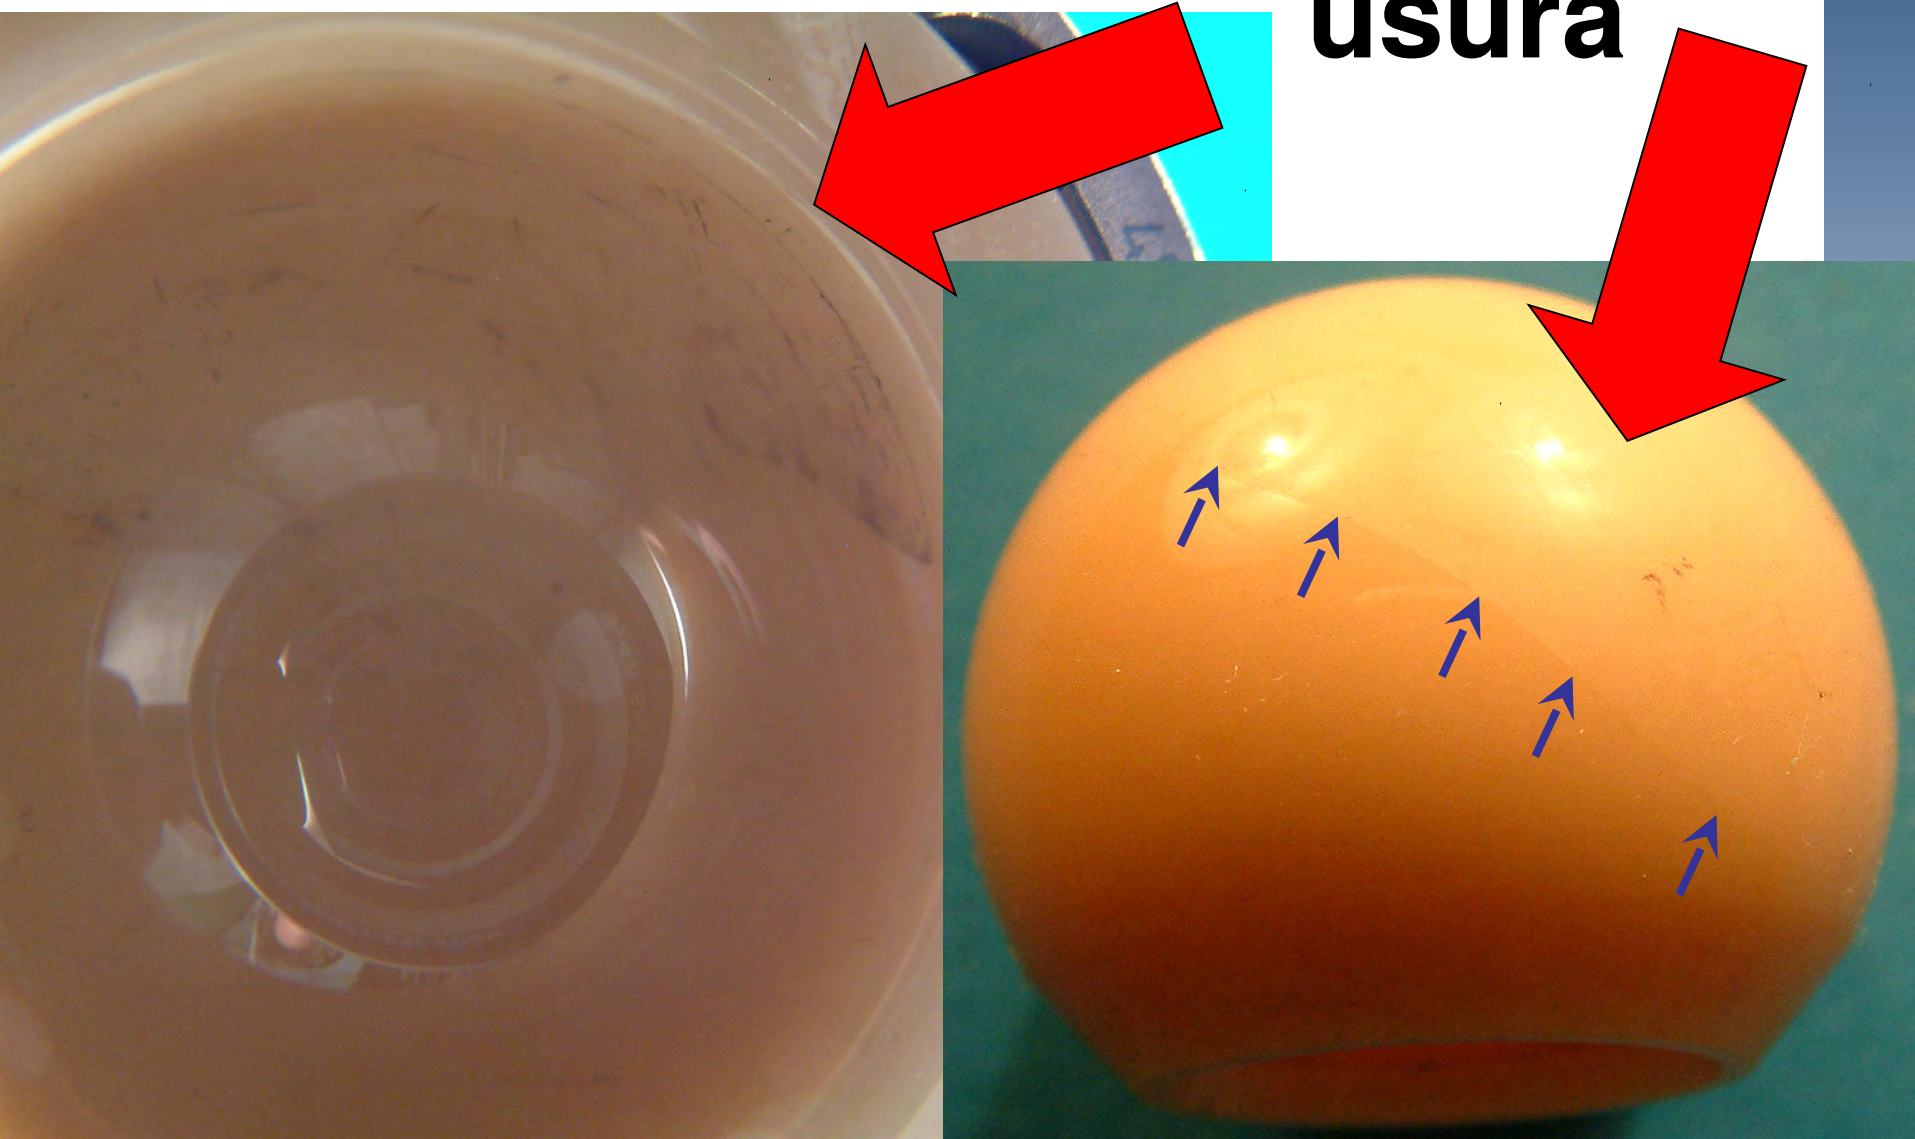
# STRIPE WEAR

**usura**

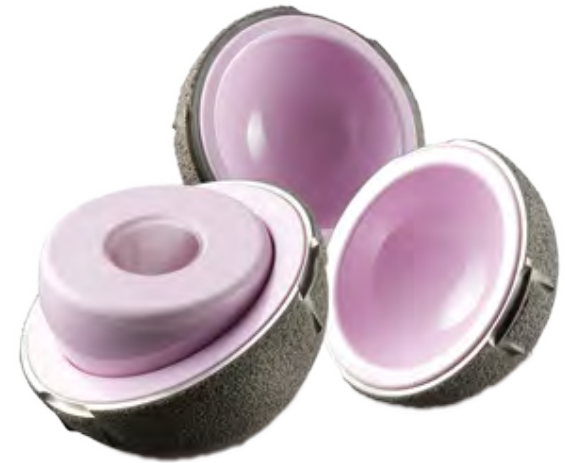
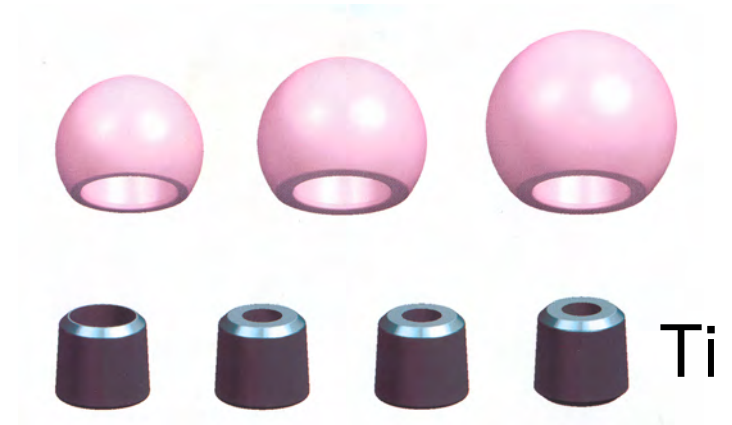
**Teste grandi  $\geq 40$  mm  
causano maggiori  
stress al cono 12/14**

**Si consiglia uso delle  
teste OPTION**

**Adattatore di **Titanio**  
per ridurre i danni da  
“Crevice Corrosion”**

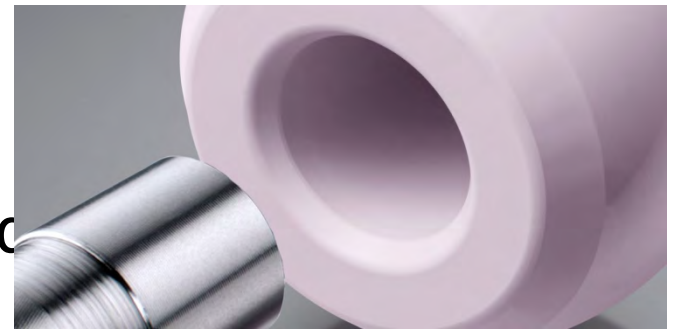
# Neck Taper and Compatibility

**The taper fixation** between a femoral ball head and a stem, familiar in hip arthroplasty, was developed at the start of the 1970s by the industry partners Sulzer AG (endoprosthesis manufacturer and predecessor of Zimmer, Winterthur, Switzerland) and Feldmühle AG (ceramics manufacturer and predecessor of CeramTec GmbH, Plochingen, Germany).

**There is still no standard for the stem taper.** Implant manufacturers continue to use tapers with their own specifications (for example, various 12/14 tapers), which differ in terms of geometry, structure and surface properties

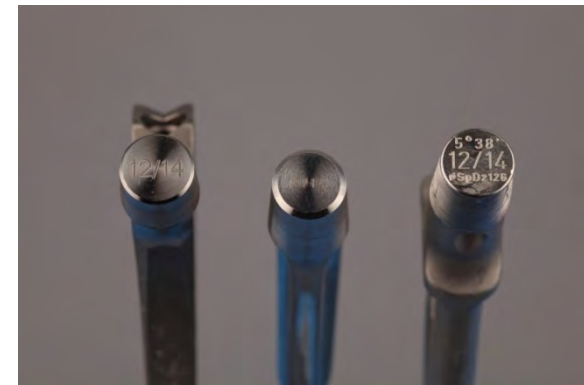
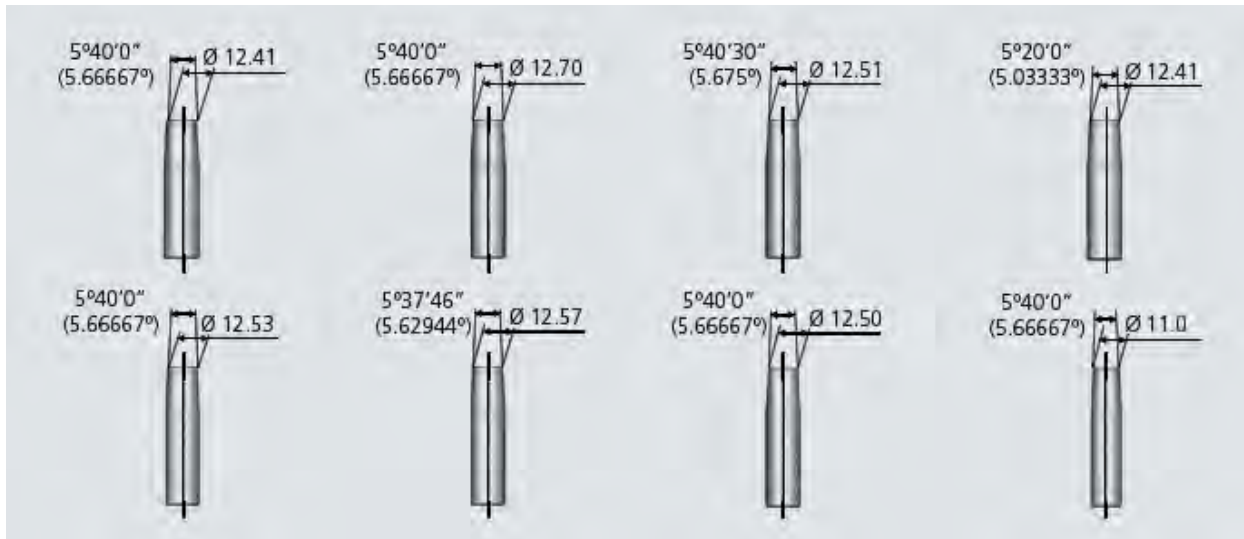
*Different tapers all of which are designated "12/14"*

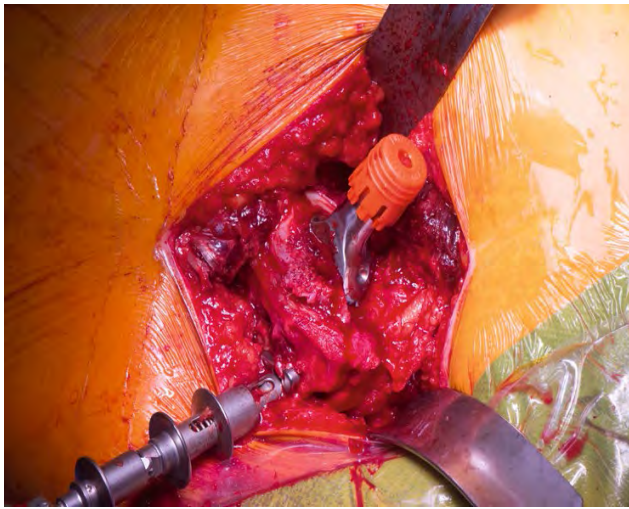
The protective taper cap **must not be removed too soon** to avoid mechanical damage to the stem taper by instruments or other objects

a) Protective taper cap

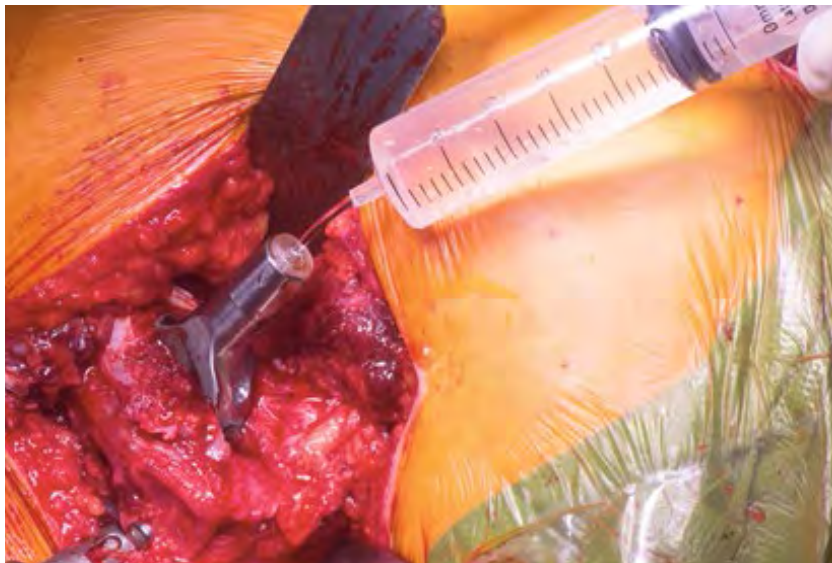
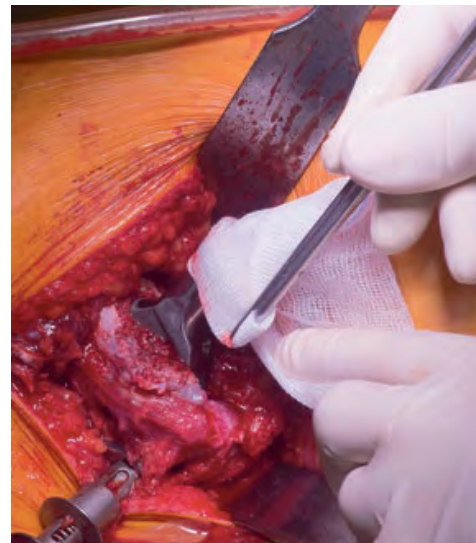
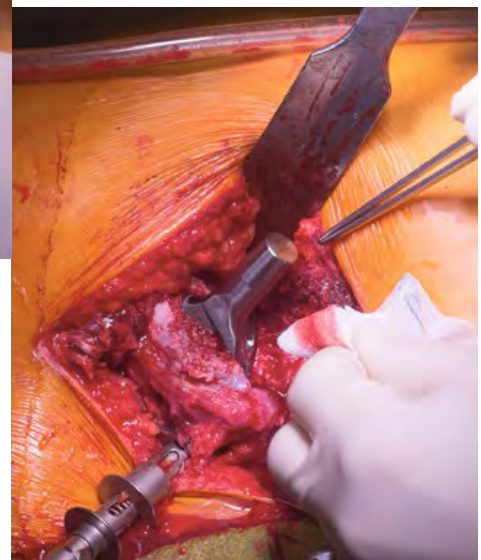
## SURGICAL TECHNIQUE: Careful Cleaning and Drying of the taper

foreign material (tissue, cement, bone, blood, etc.)  
affects the transfer of force to the ceramic femoral ball head  
and has a negative impact on the fracture strength  
of the femoral ball head

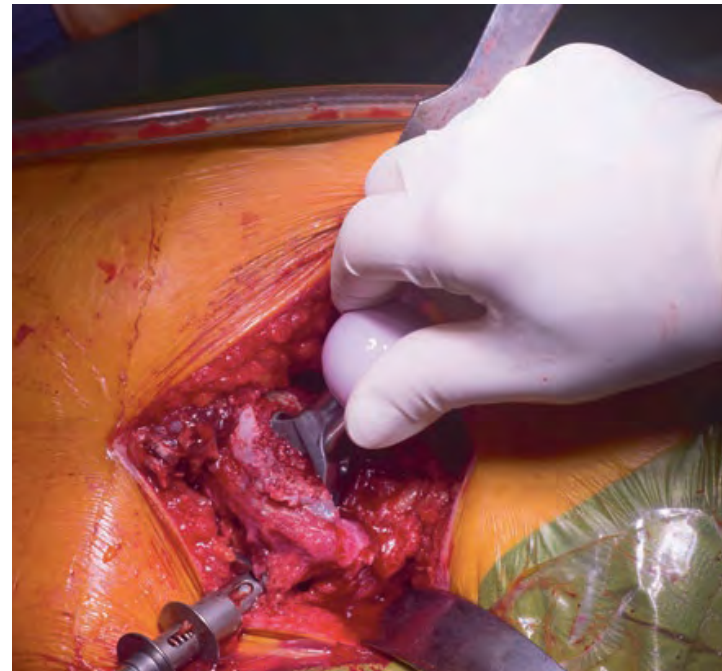
**Positioning of the head in the axial direction. Slight turning motion when positioning the femoral ball head**

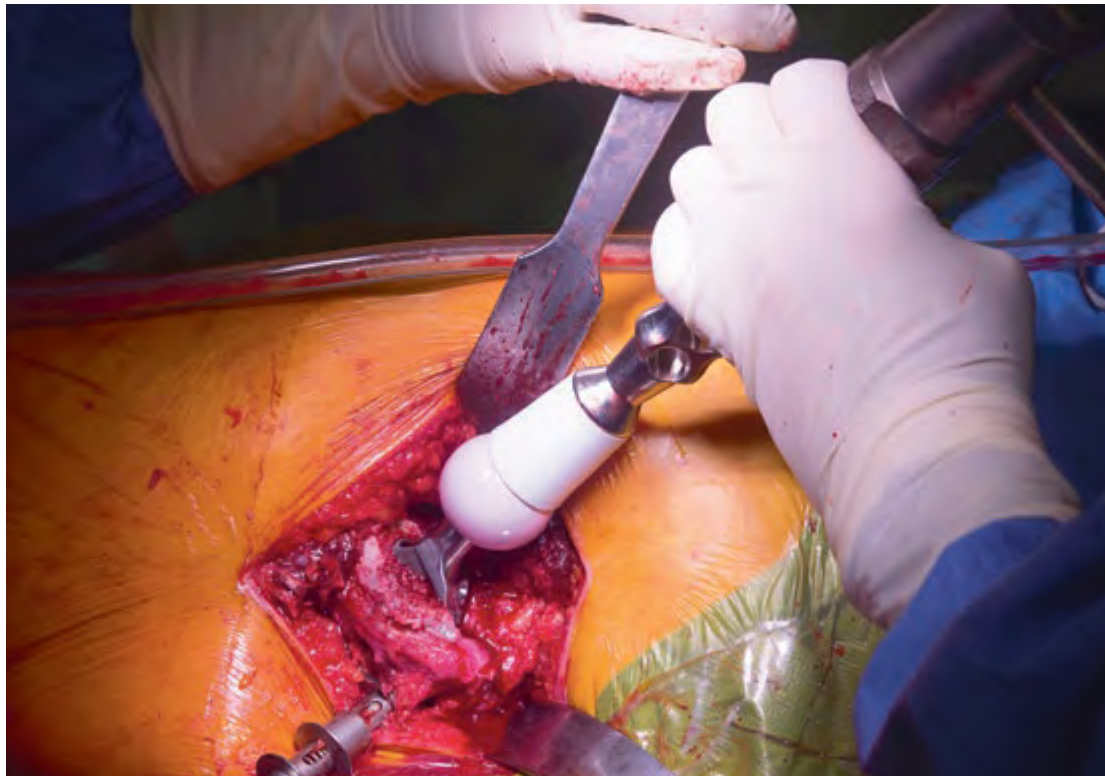
## SURGICAL TECHNIQUE: Impacting the femoral ball head

with a suitable instrument, **using a moderate hammer blow on the impactor in the axial direction of the stem taper** will ensure the femoral ball head is seated firmly.

A single hammer blow is sufficient, although several blows are permitted.

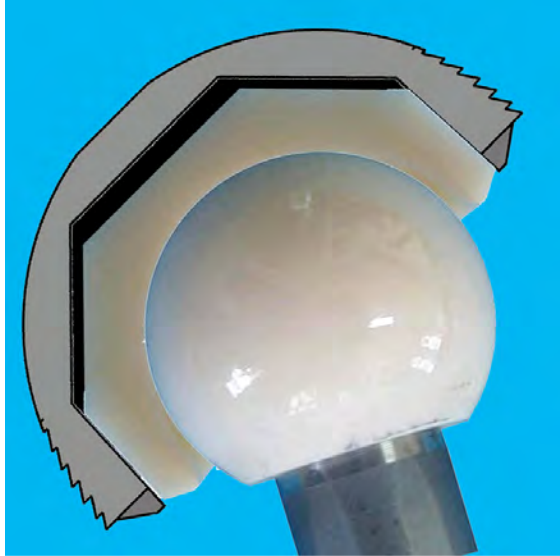
# Fracture mechanics

Malorientation or  
bad rim design

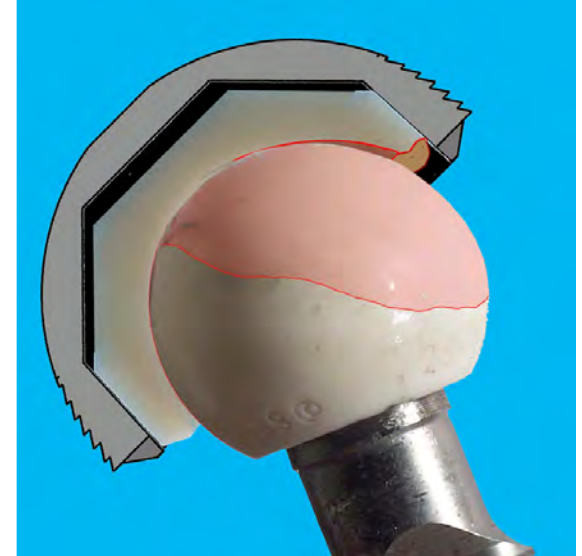
- Neck impingement –  
sub dislocation
- Very small contact on the  
rim
- Grain detachment

- Third body wear
- Crack propagation

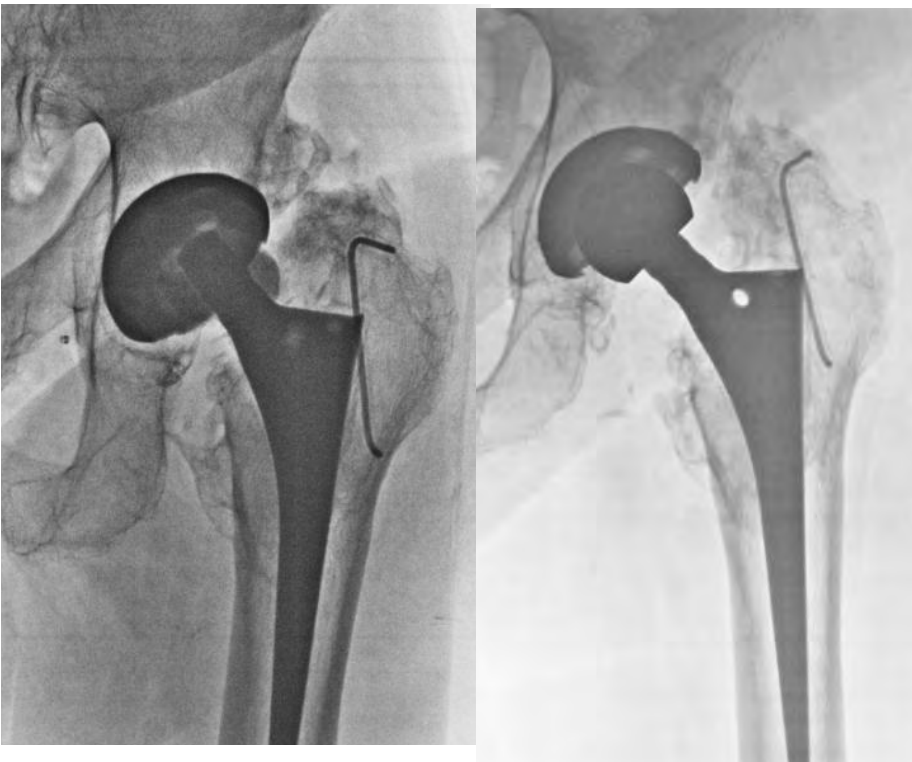
# Bony impingement

Female, 75 years,  
16 years post op., H.O.  
Liner and head fracture

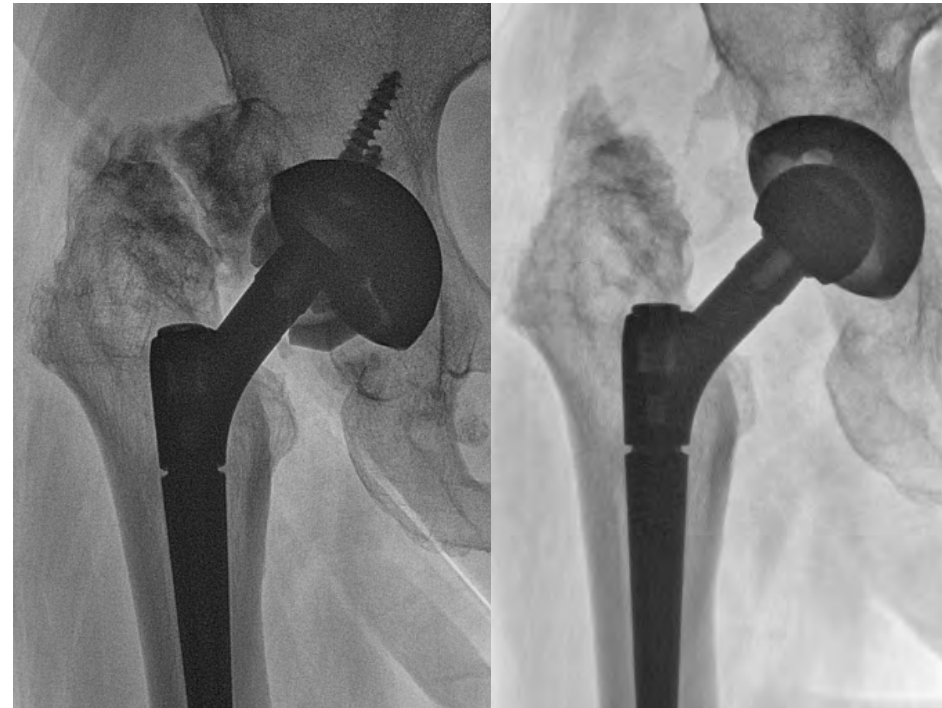
Female, 73 years,  
15 years post op., H.O.  
Liner fracture

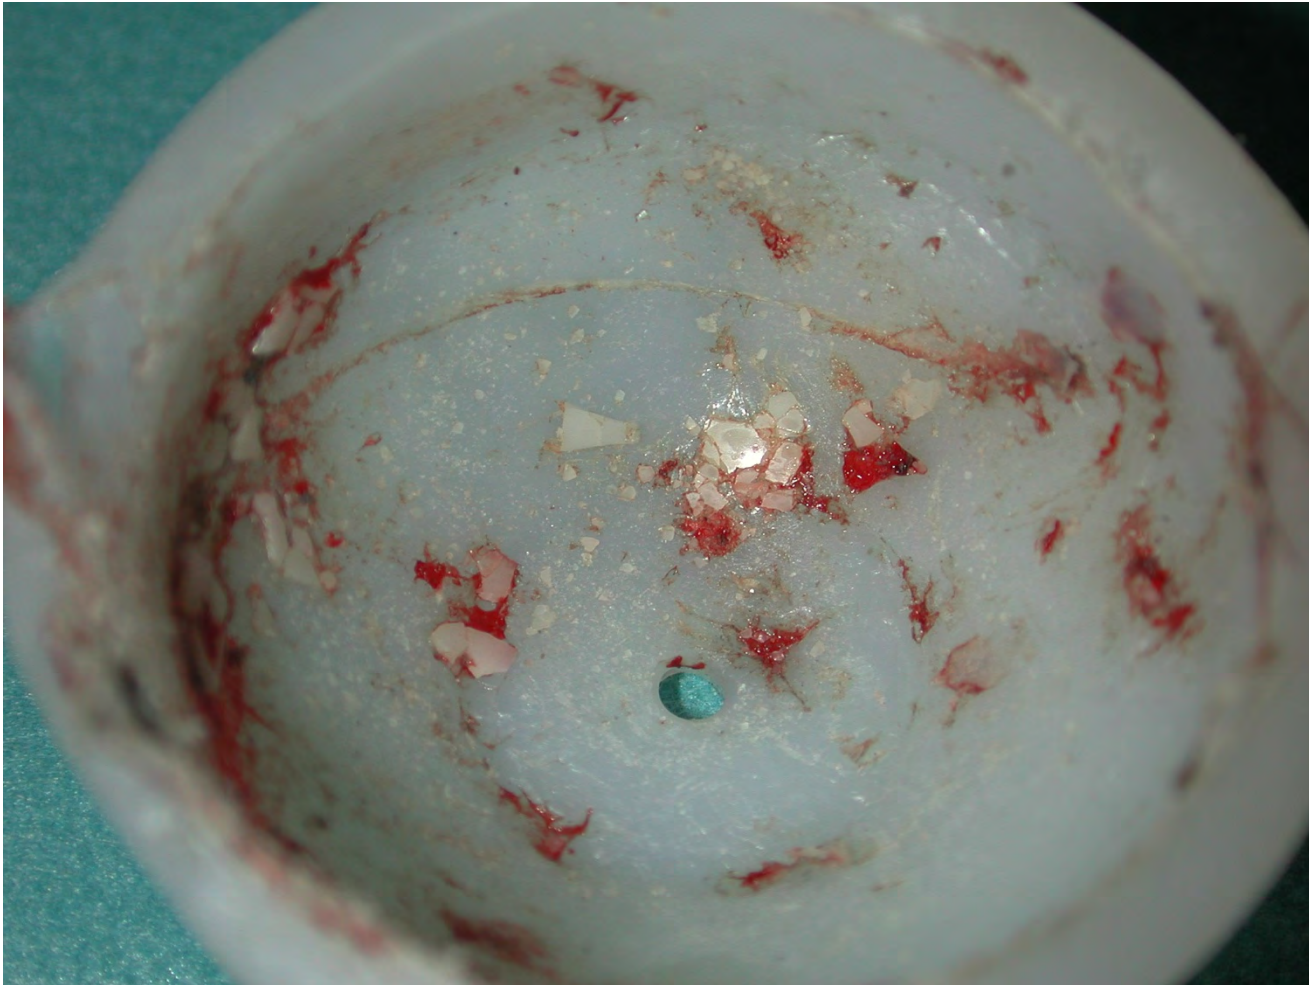
## Ceramic on Poly

Small ceramic fragments can impact in PE, less damage

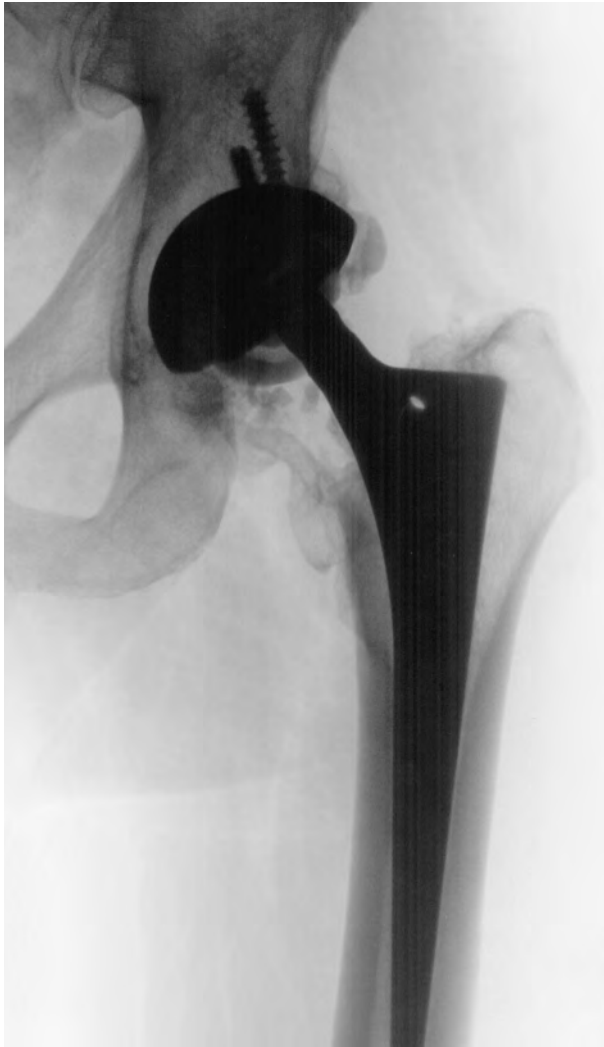
Male, 74 years, fracture of PE sandwich ceramic liner

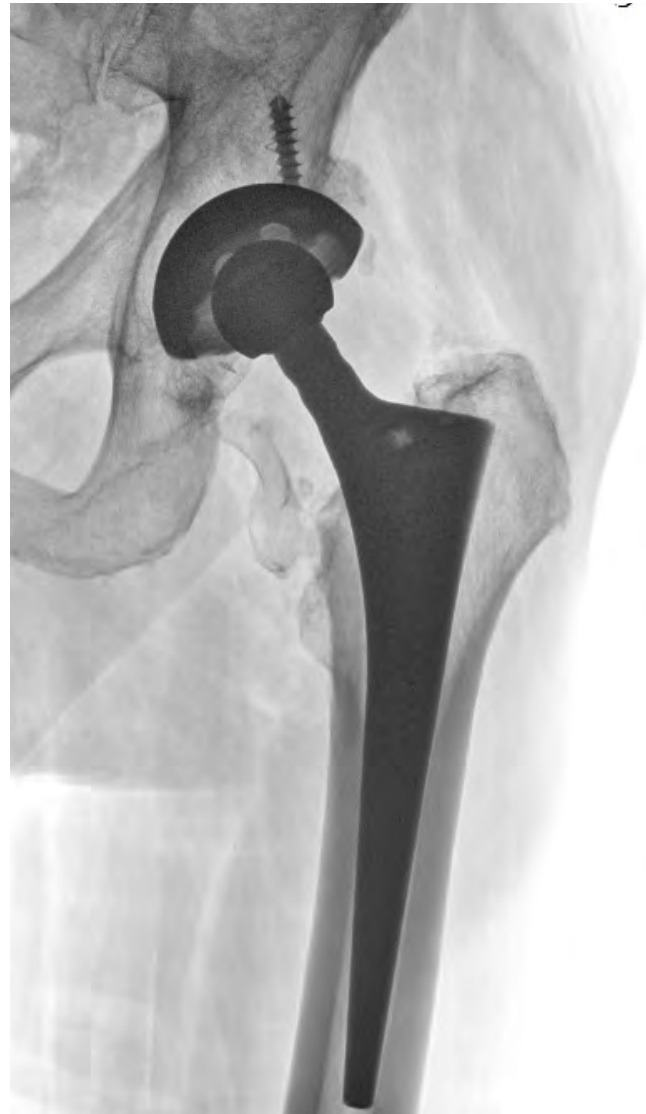
Cer-PE 10 years post op.

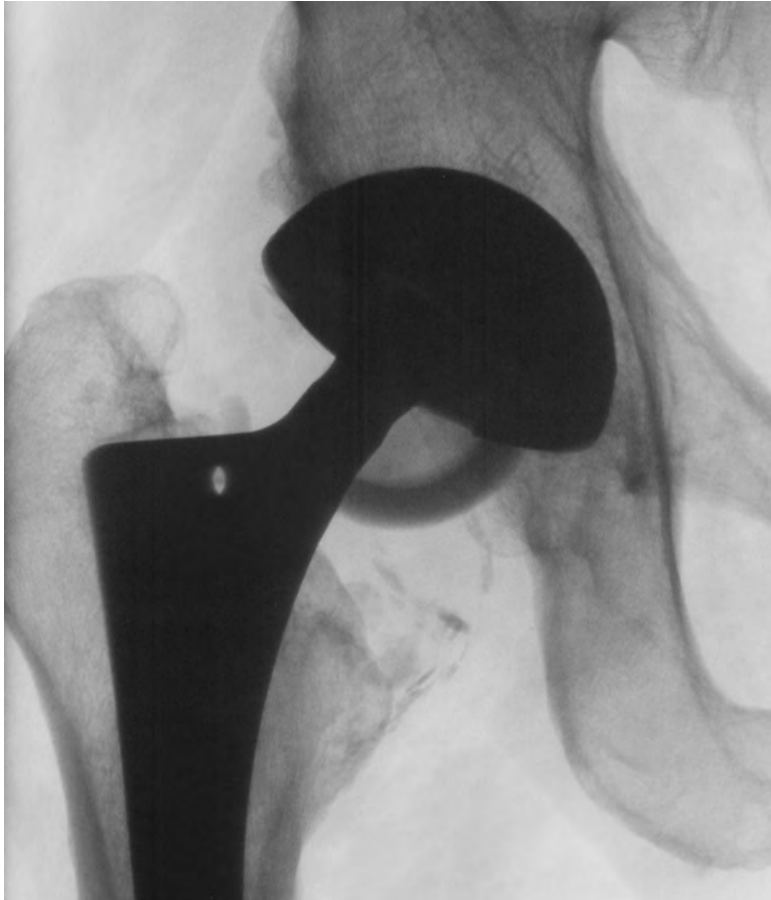
Male, 70 years, fracture of PE sandwich ceramic liner 2.5 years after THA

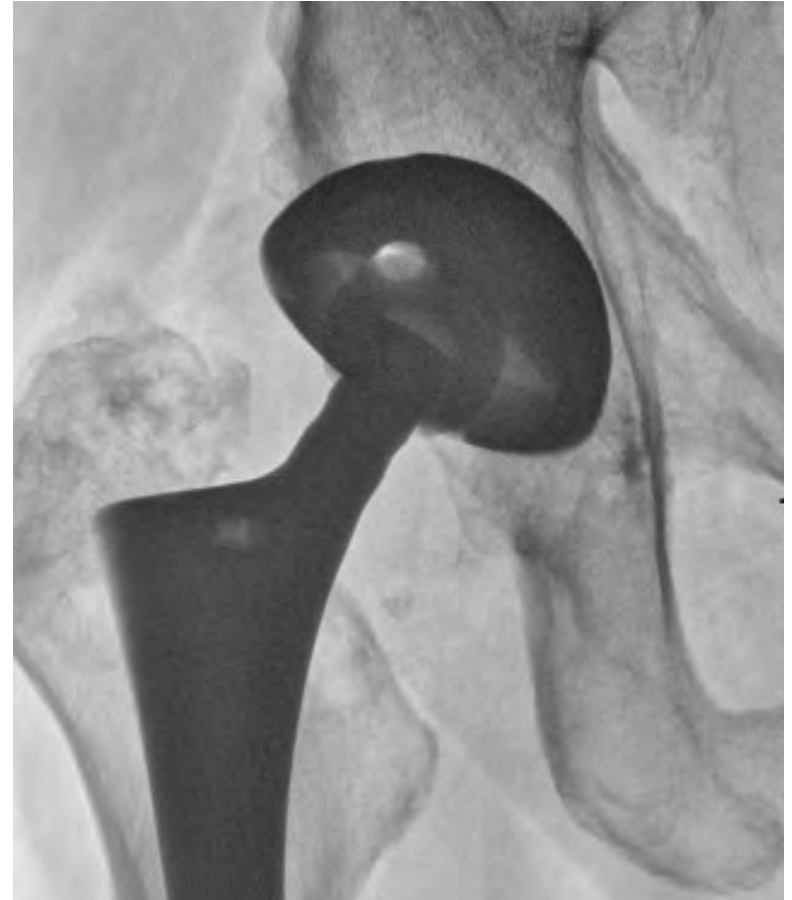
Cer-PE 13 years post op.

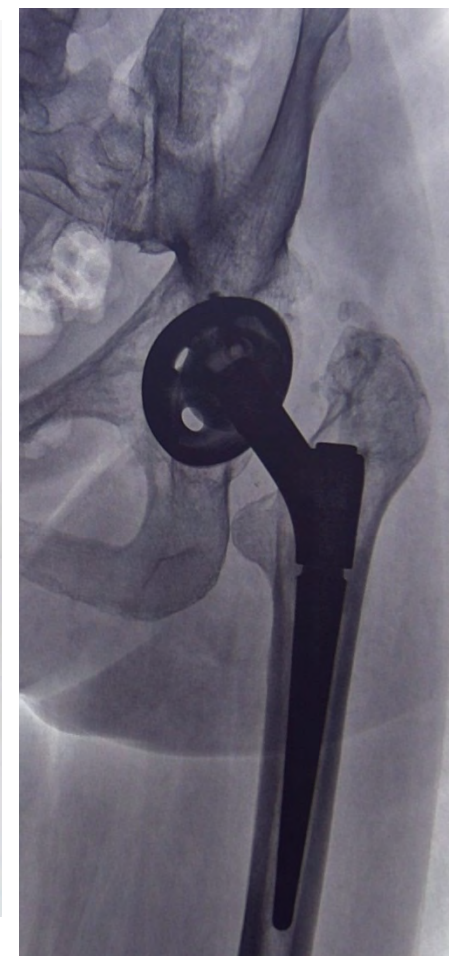
Wear 9 years later

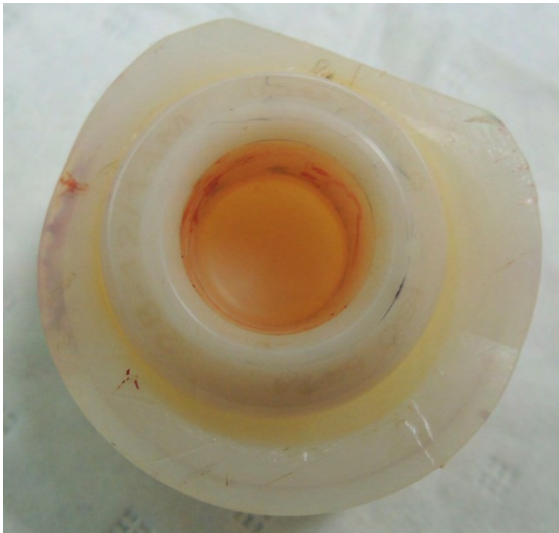
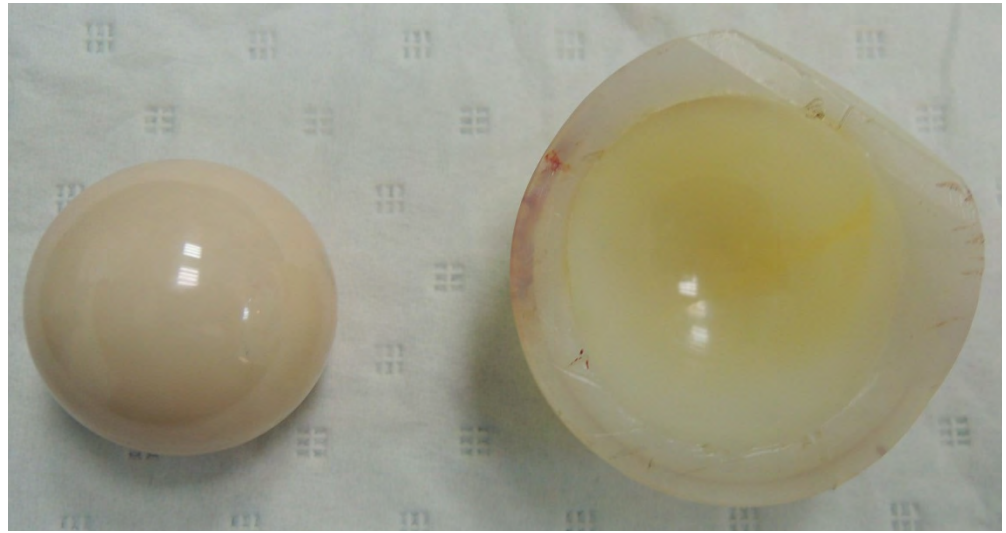
PE wear 10 years after surgery,  
no ceramic fragments

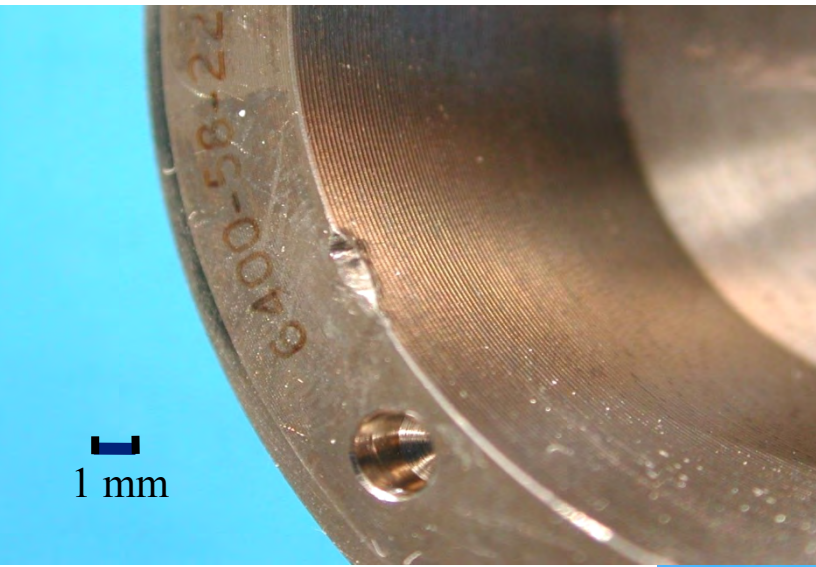
# Damage of the metal back

Breakage during the  
insertion of the liner

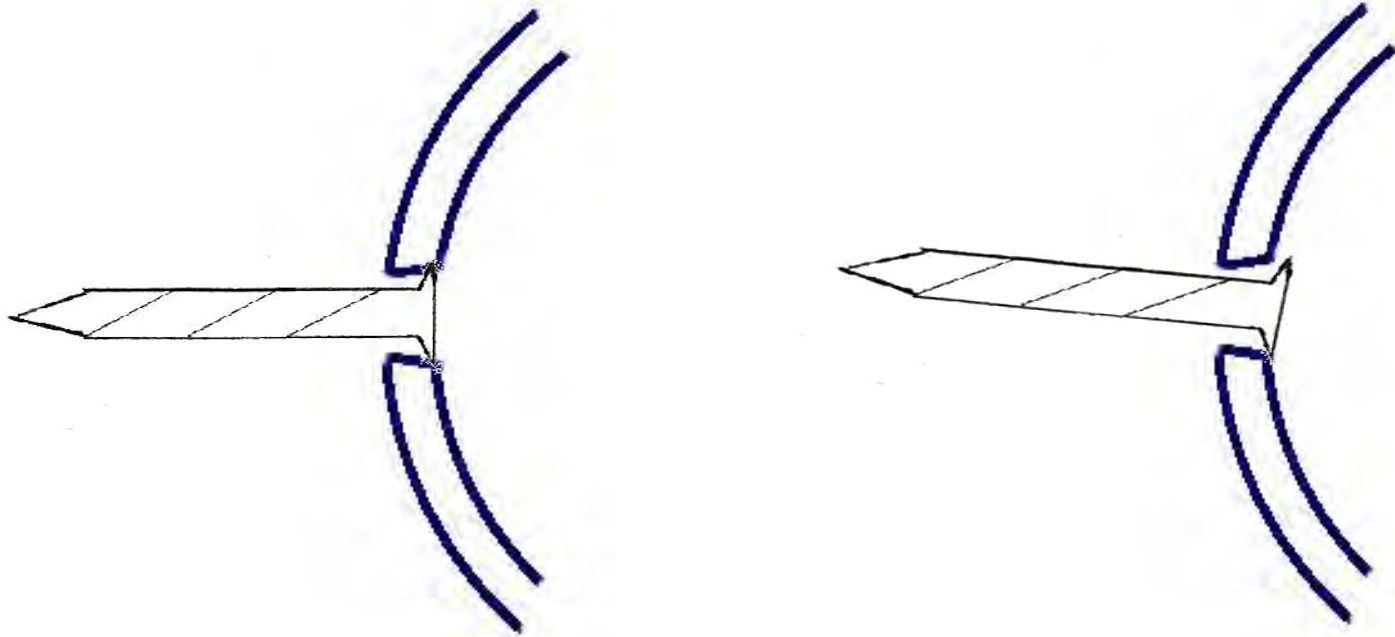
## Additional screws

Fracture of the liner probably due to “malpositioning” of the screws protruding into the metal back

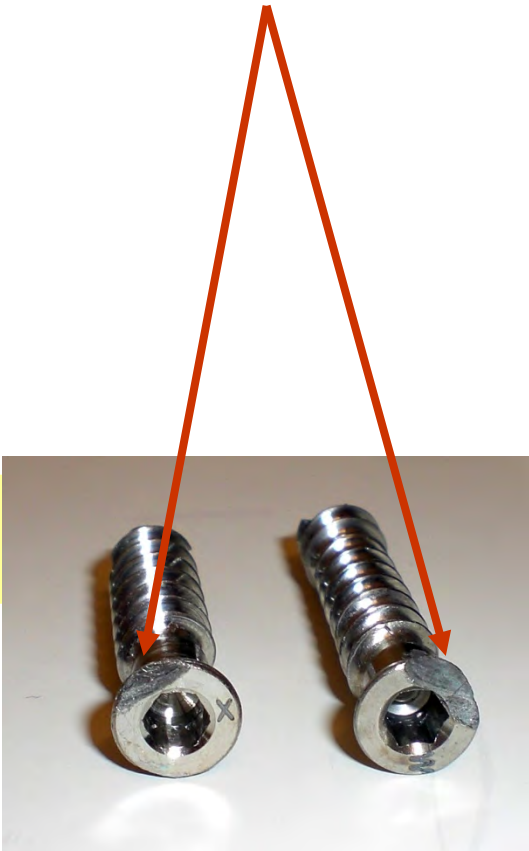
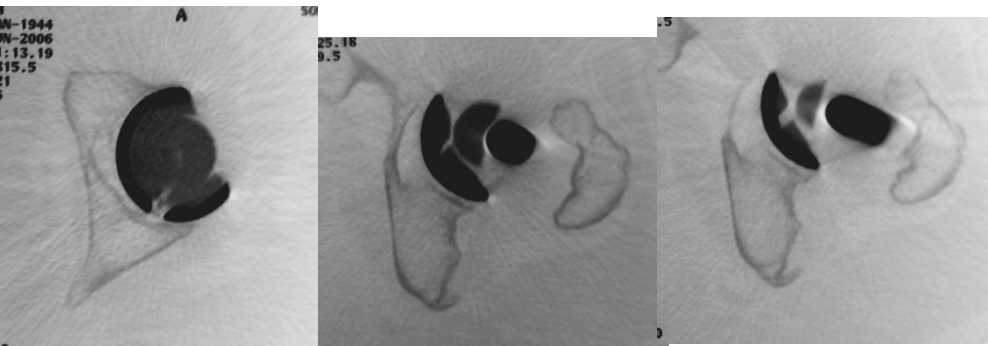
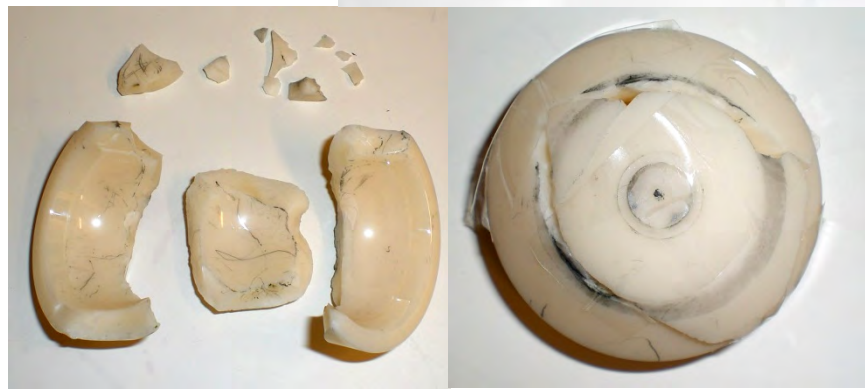
Female, 69 years

Loosening of the cup after 5 years of  
cer-cer, osteolysis due to Ti debris

Cer-XPE 36 mm
